## TECHNICAL INFORMATION LETTER

### DANGERS OF BEARING REFURBISHMENT

This TIL applies to all Load and Compressor Gearboxes

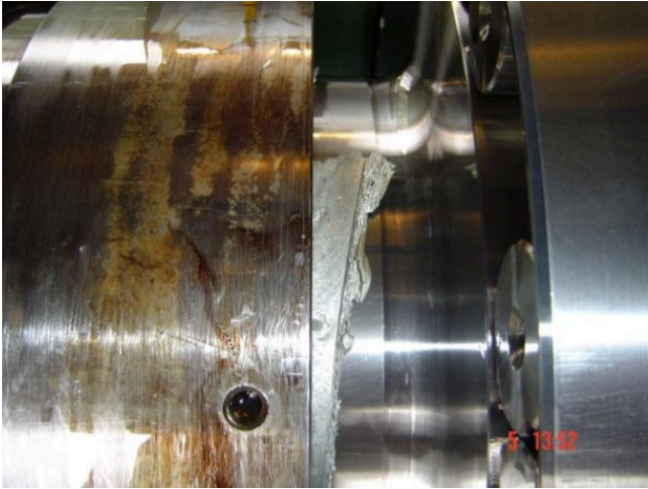
**Figure 1: Sliding of white metal**

Based on our experience we **DO NOT RECOMMEND** to repair the used or damaged bearings.

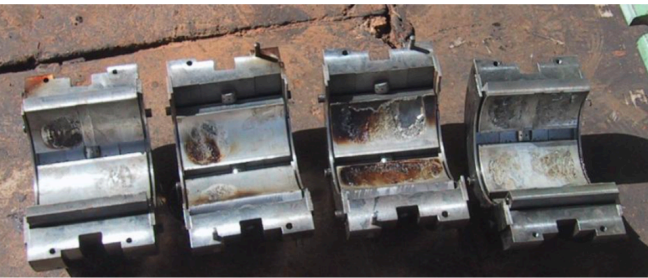
**Figure 2: Damage to white metal**

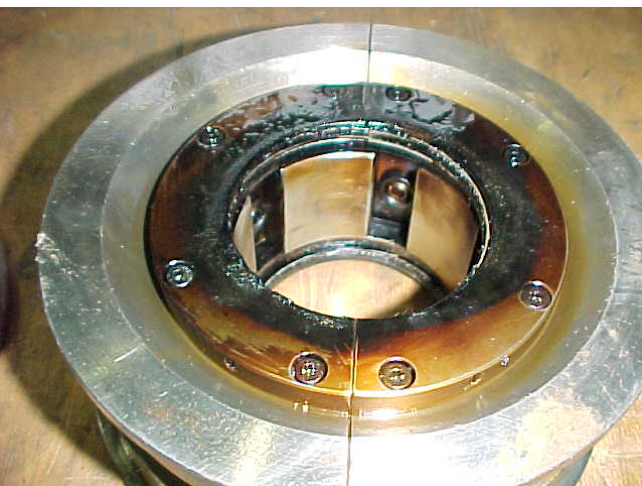
**Figure 3: Failed refurbished Bearing**

During the above outlined operations the bearing is machined, heated up, cooled down and machined again which has the consequence of a build up internal stress in the steel of the bearing surface.

The metal body of the bearing goes through deformation and gets twisted i.e. the outer diameter is still within the dimensional tolerances, but it will fail its geometrical tolerances.

**The last machining operation doesn't allow the bearing to remain within the tolerances for the concentricity AND the parallelism.**

At the time of putting a refurbished bearing into place inside the casing, the outer diameter goes back to its previous position, leading to a deformation of the inner diameter.

As a consequence, the contact pattern of the shaft inside the bearing is partial and would lead to a significant disturbance of the dynamic behavior of the bearing generating:

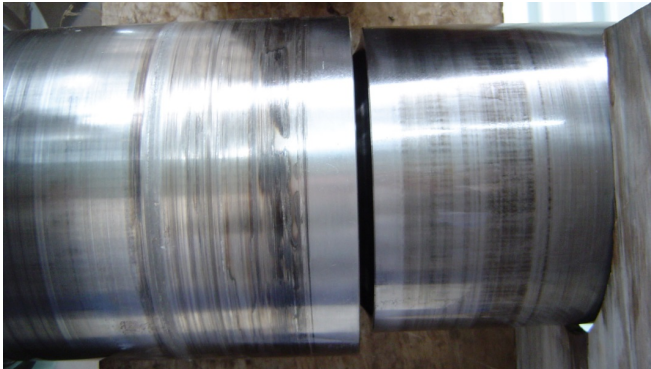
The final damages can range from damages to the shaft journals, as well as the tothing of the gears necessitating replacement of the entire gear set.

**Figure 4: Damage to the journal area after failure of refurbished bearings**

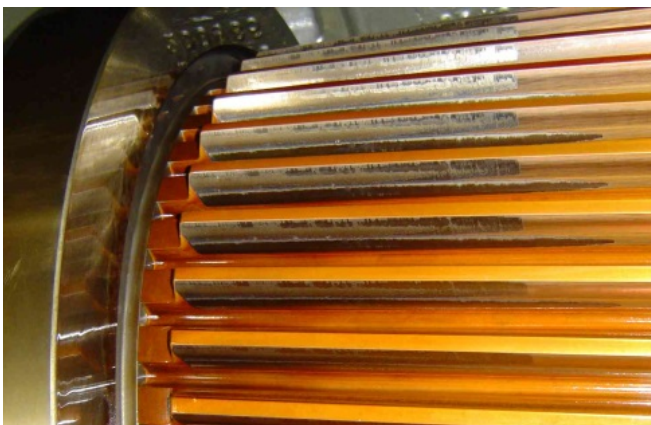
**Figure 5: Damage to the teeth after refurbished bearing failure**

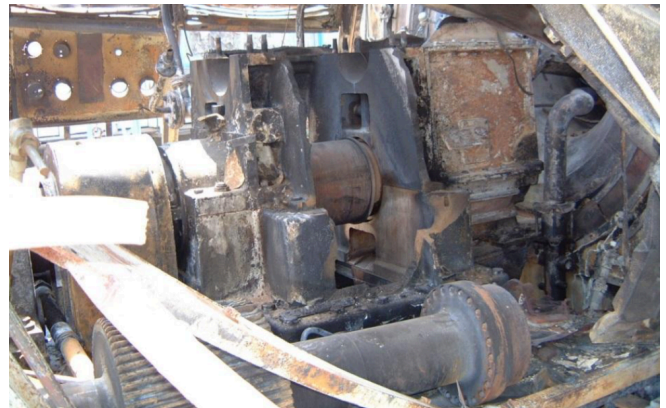
Below examples are from a site in Saudi Arabia which required our intervention and RCA.

**Figure 6: Gearbox explosion due to failure of bearing at load**

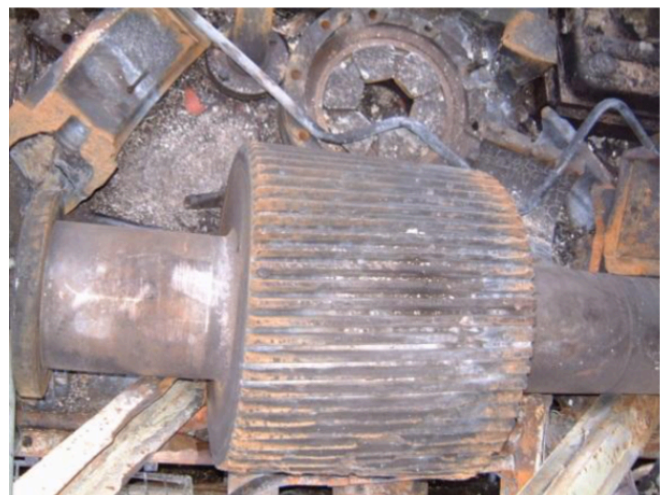
**Figure 7: Total destruction of the gearbox**

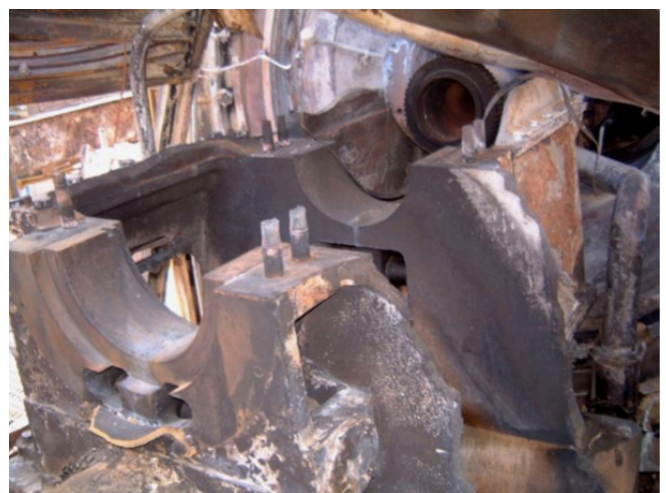
**Figure 8: High Damage to surrounding equipment**
